**Apollo Theatre, Shaftesbury Avenue**  
**Structural engineering notes on ceiling collapse**  
**Prepared for Westminster City Council**  
**December 2014**  
**Alan Baxter**

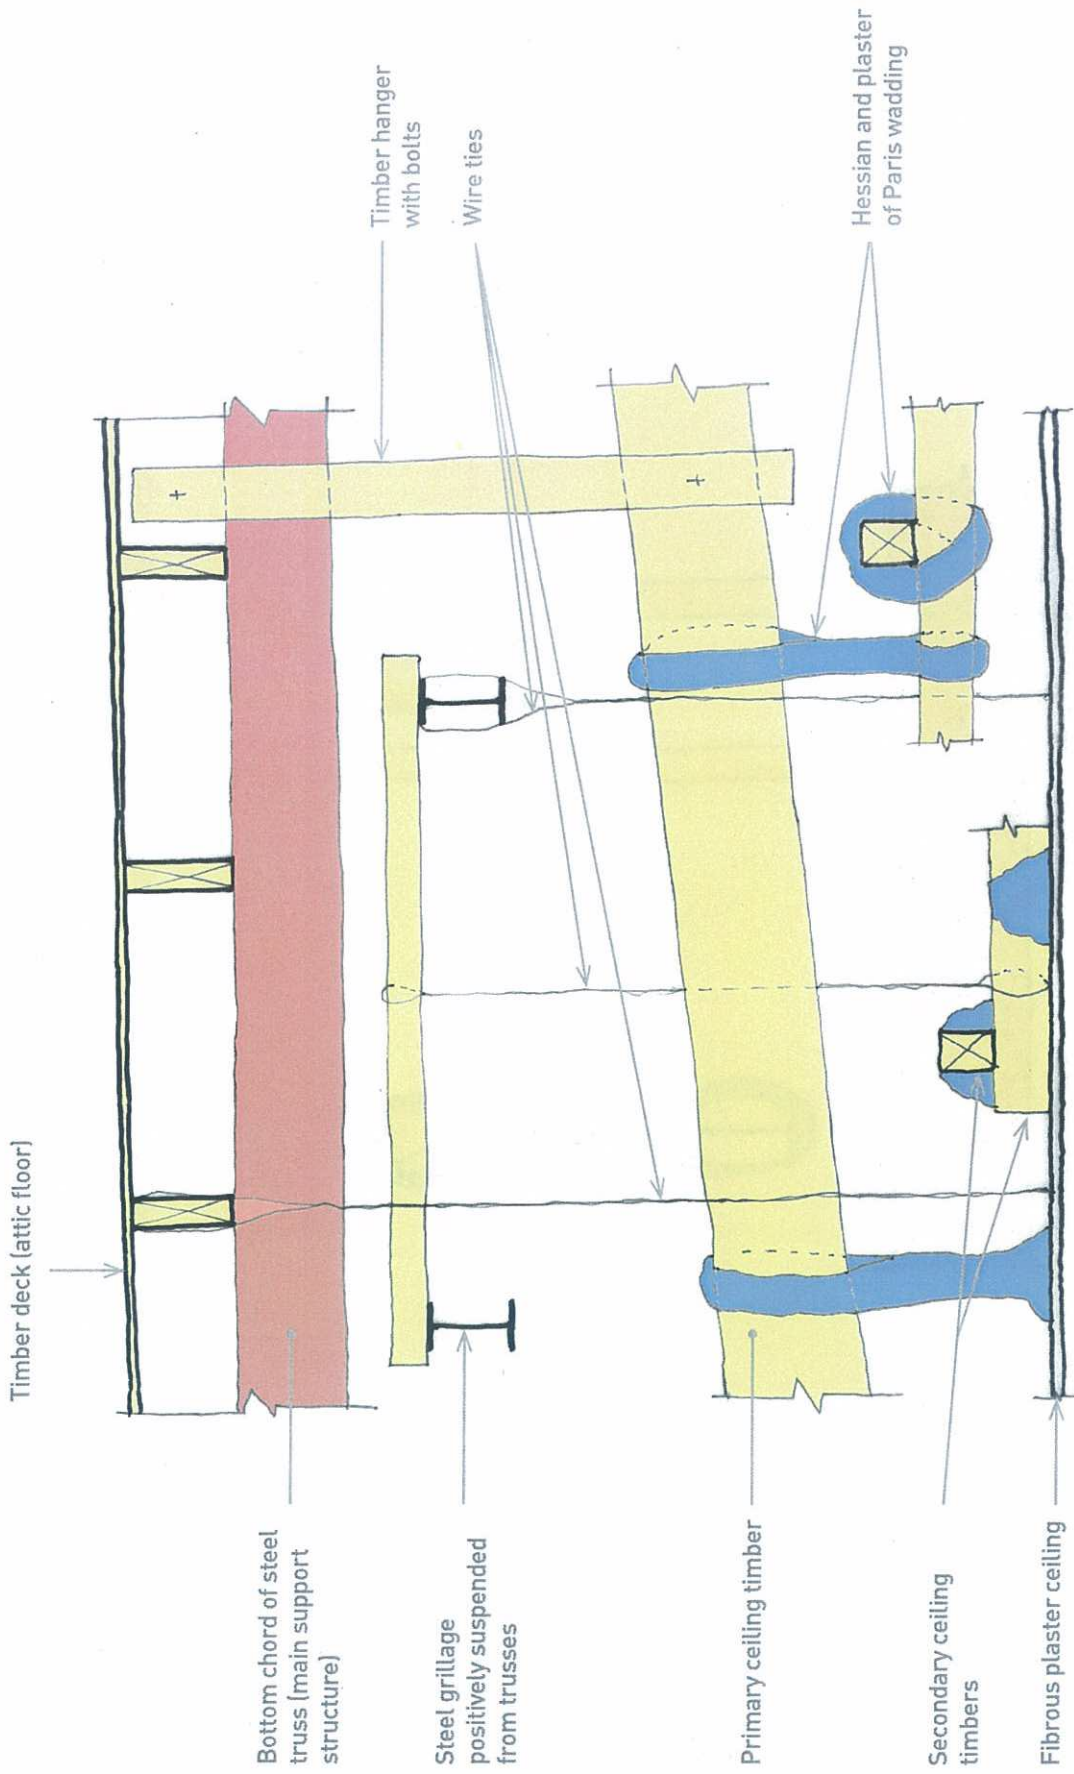
Sketch 3: Indicative section showing ceiling construction and supporting structure

- 3.5 Below the steel beams is an arrangement of timbers which is fixed directly to the main structure above with bolted timber hangers, bolts and possibly nails. These are arranged in a roughly radial pattern and have a fairly logical form. This layer would likely have been constructed by the main building contractor and it forms the basic carcassing that the ceiling installers would then fix the fibrous plaster ceiling to. To differentiate them from the timbers below, these are referred to in this report as the primary timbers.

- 3.6 Below this main carcassing is the ceiling construction which is far less logical. There is an arrangement of timbers to which the fibrous plaster ceiling panels are directly fixed to, or hung from. Due to the complex geometry of the ceiling these are in several layers and they are arranged in a very ad hoc way. In this report we refer to these as the secondary timbers and these would have been erected by the ceiling installers. These form layer one of the ceiling construction.

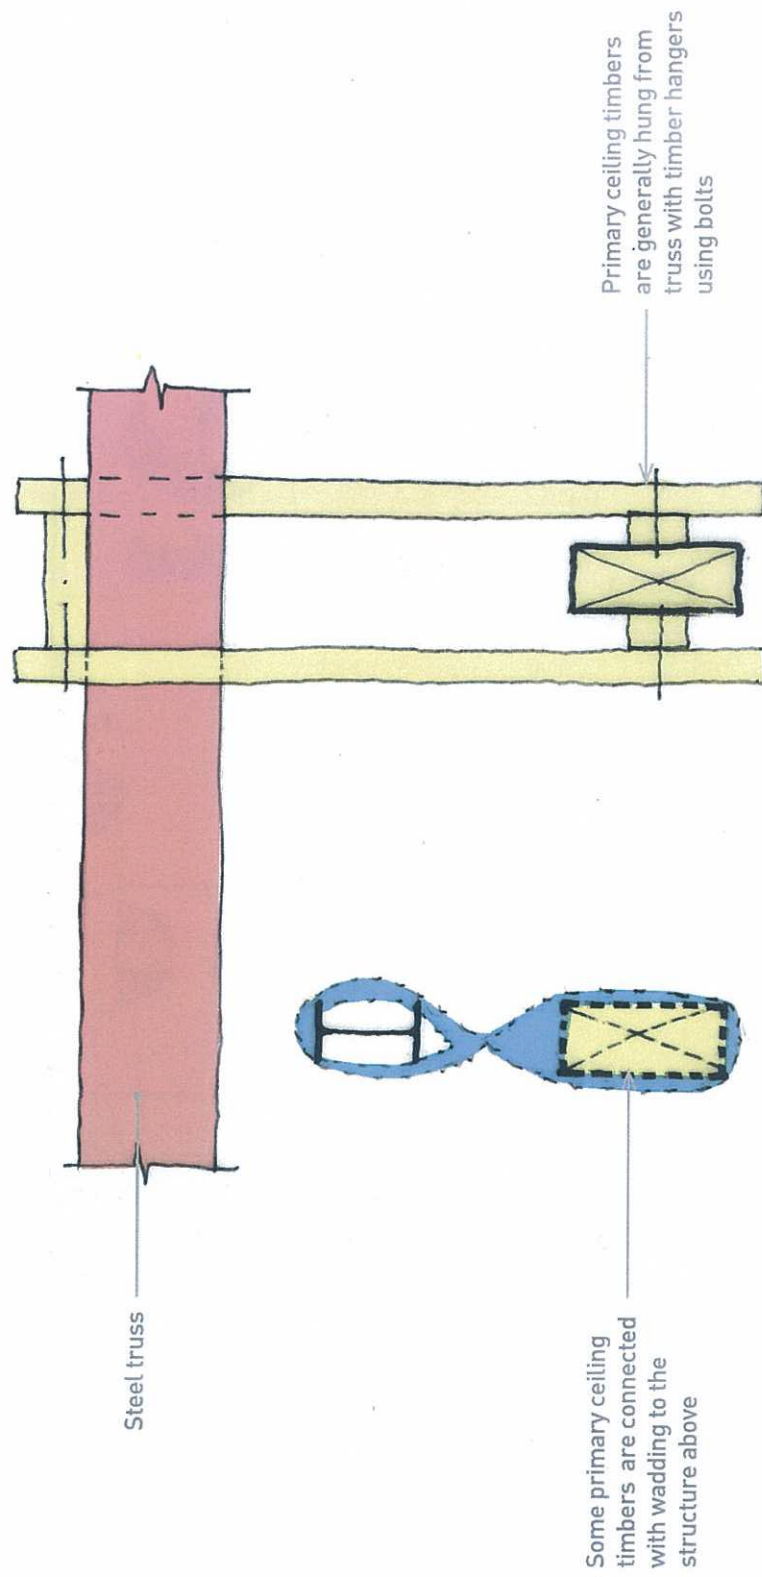
Sketch 4: Typical primary ceiling timber/ main structure connection

- 5.2 The timber hanger connections between the primary timbers and the steel structures above appear in reasonable condition and show no signs of failure.

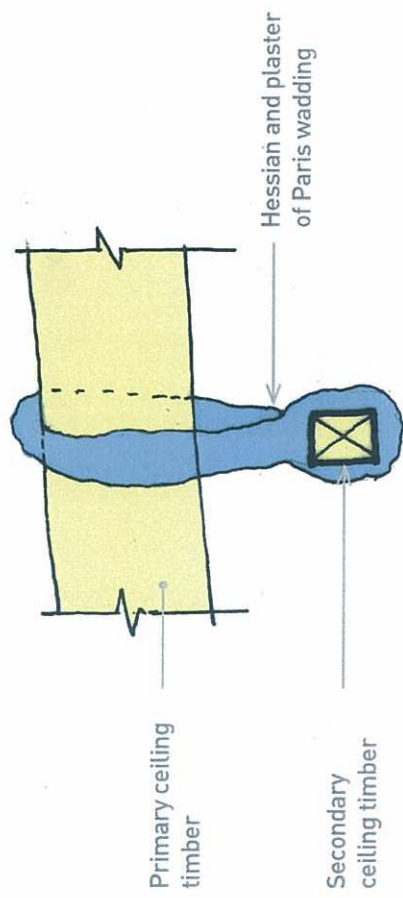
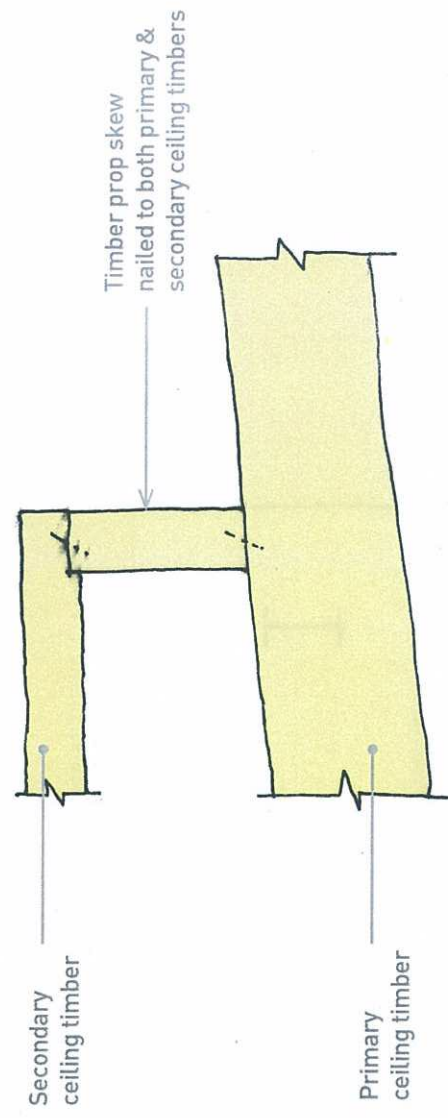
Sketch 5: Typical primary/secondary ceiling timber connections

- 3.8 There are some wadding ties added between some primary timber members and the main structure. It is not clear why this was done, but it may have been because the ceiling craftsmen considered that the bolted and nailed fixings of the primary timbers were not adequate to support the loads that their method of ceiling installation imposed on these members. Again this all appears to be ad hoc and empirical, based on the experience of the ceiling installers.

- 4.3 The detachment of the ceiling occurred as a result of wadding ties between secondary and primary timbers and between the fibrous plaster panels and the ceiling timbers failing. Wire ties remain and in general the loops where they were wound around the timbers are still there. It is clear that where the wires ties were connected to laths within the fibrous plaster panels, when the collapse occurred the laths fractured.

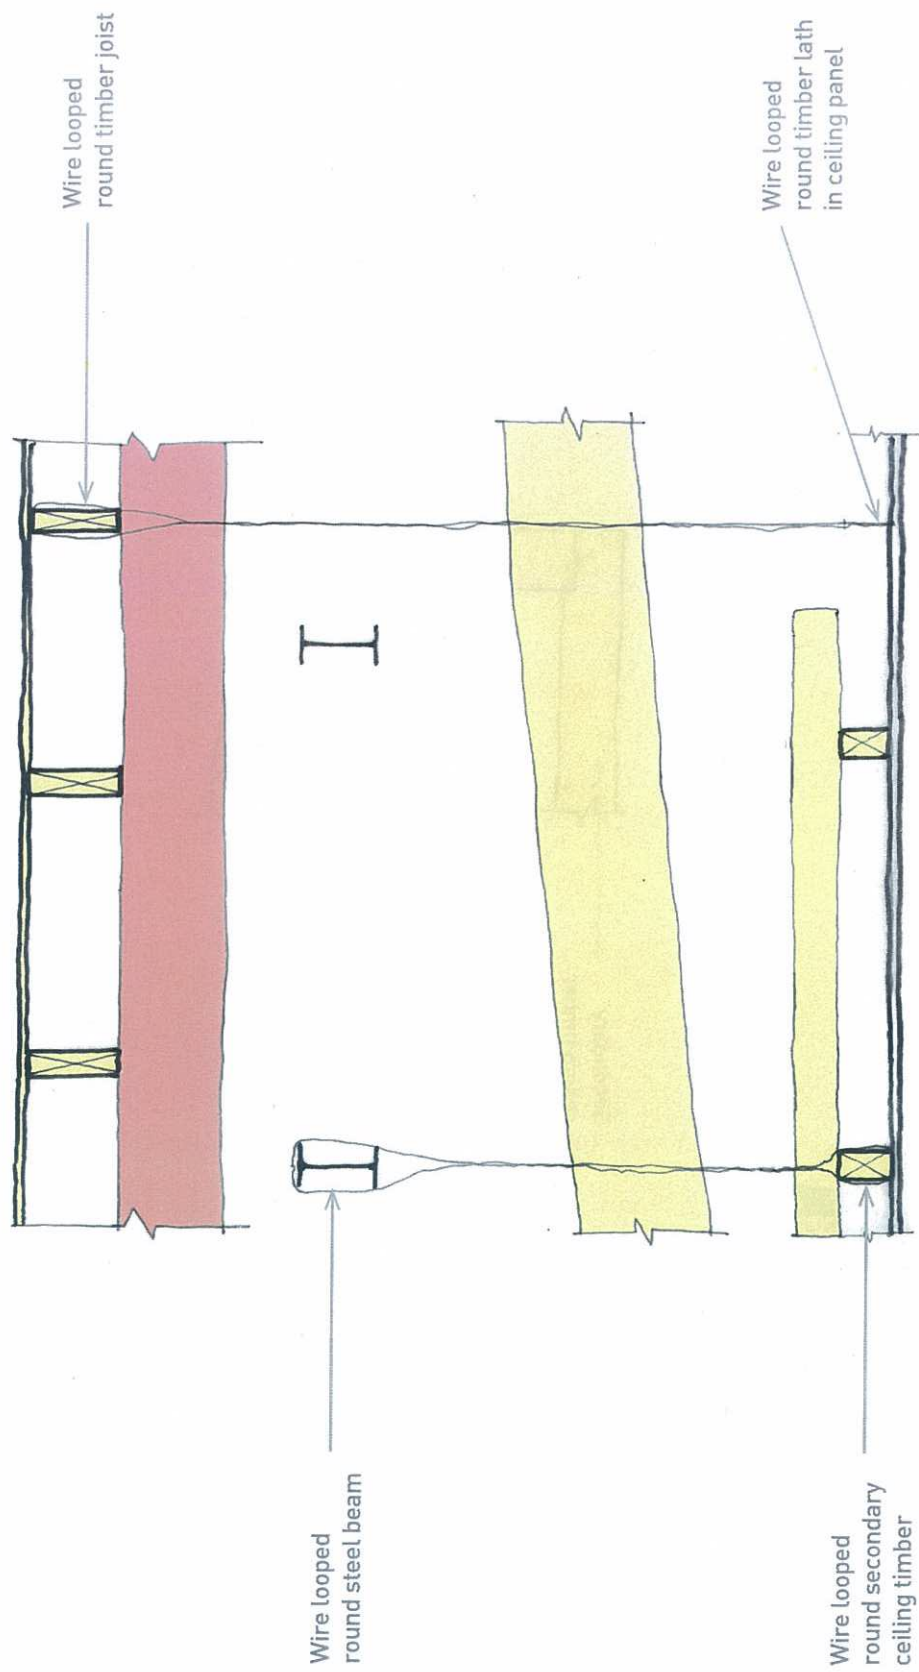
Sketch 6: Typical wire fixings

These wire ties appear to be original, as some of them are embedded into the timber laths used in the construction of the fibrous plaster panels. It appears that these wire ties were used to hang the ceiling panels in place and adjust them to achieve the complex ceiling geometry while the secondary timbers and wadding ties were installed. These wires all have four strands and are consistently wound to tighten them up and achieve the adjustment required. The fact that some of the wires pass around laths in the panels means that they could not have been intended to act as long term ceiling supports. The laths are small in cross section and are not able to support high loads which would exist if all of the ceiling load, including the added secondary timbers, was to be taken by the wire ties.

- 3.10 There are also some wire ties between secondary timber members or wound between secondary timbers and primary timbers or the main structure. These are also four-strand wires in the same way as the ceiling panel wire ties described in 3.9. The likelihood is that these too were used to temporarily locate and adjust the ceiling construction timbers until the hessian wadding ties were added.

- 3.12 There are a few "two strand" wire ties, which have been drilled and anchored via discs through the plaster of the ceiling itself. These are likely to have been installed as part of some post-original remedial works.
