FIBROUS PLASTER CEILING INVESTIGATION

THE APOLLO THEATRE

SHAFTESBURY AVENUE

AUDITORIUM CEILING

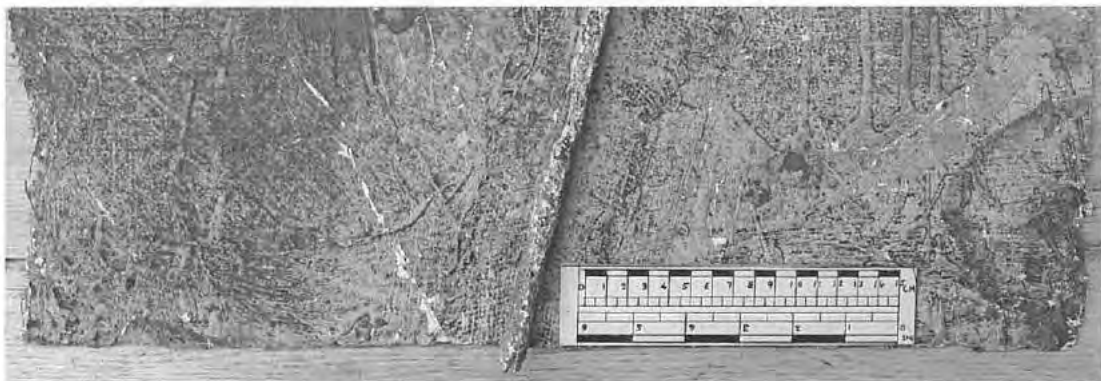
Plate 10 Front and back of typical fibrous plaster section from the Palace Theatre London, (opened 1891) showing the use of lath to provide additional reinforcement to a flat panel

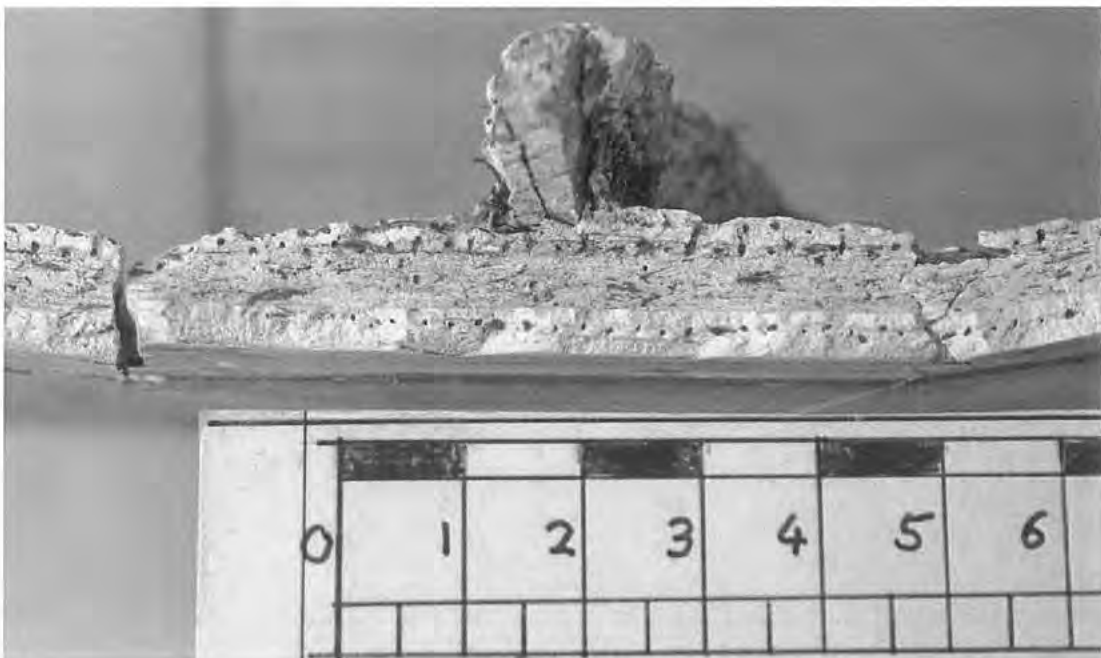
Plate 11 Detail of Plate 10 (above) giving edge on view of plaster section showing exposed hessian scrim incorporated in plaster and lath on edge for additional panel support and with whiter 'firsts' layer distinct from the subsequent greyer 'seconds' layer of plaster

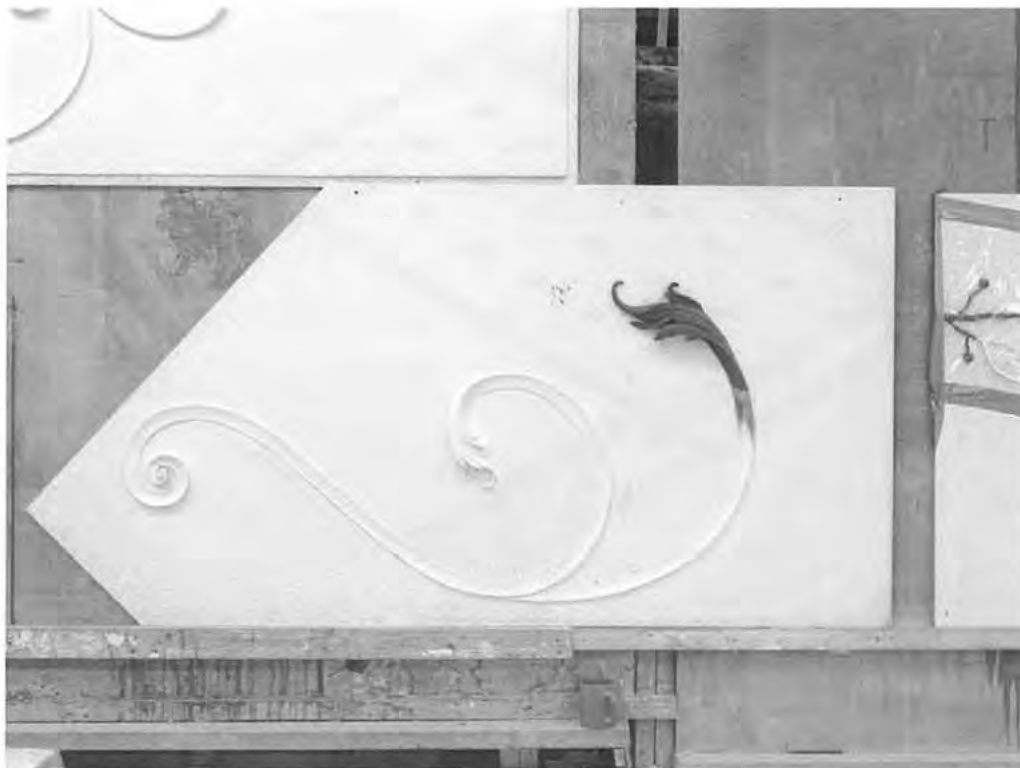
Plate 19 Cast fibrous plaster ceiling panel section forming part of a new ceiling installation

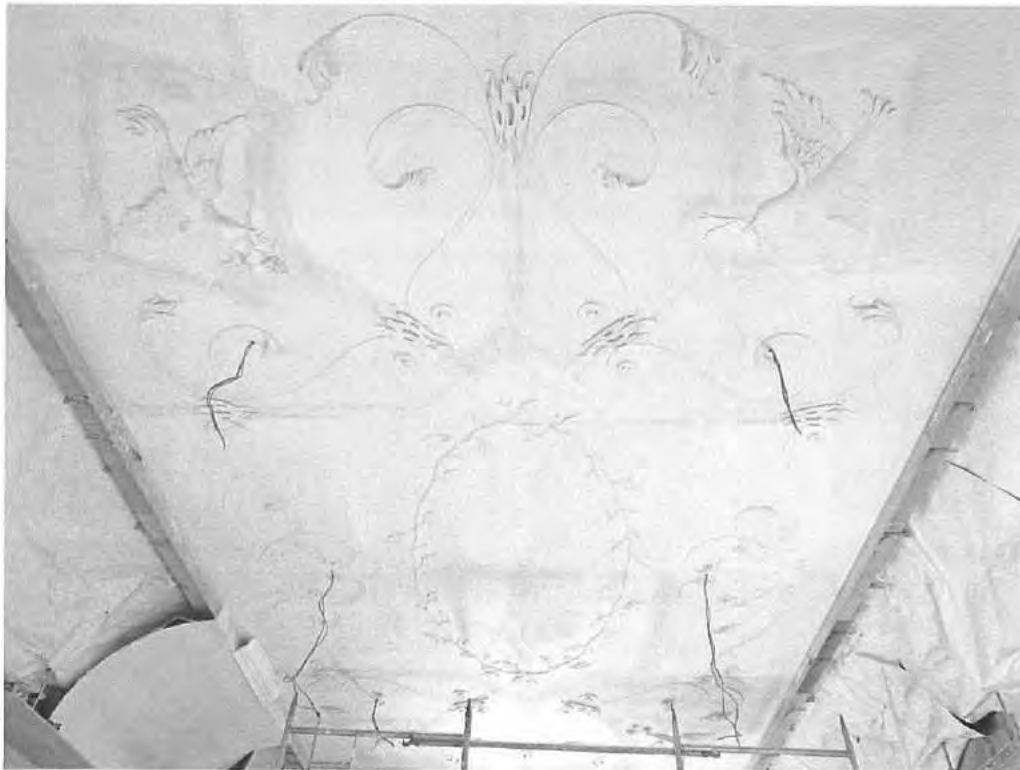
Plate 20 Suspension and making good of modern 24 panel fibrous plaster ceiling bed 2012

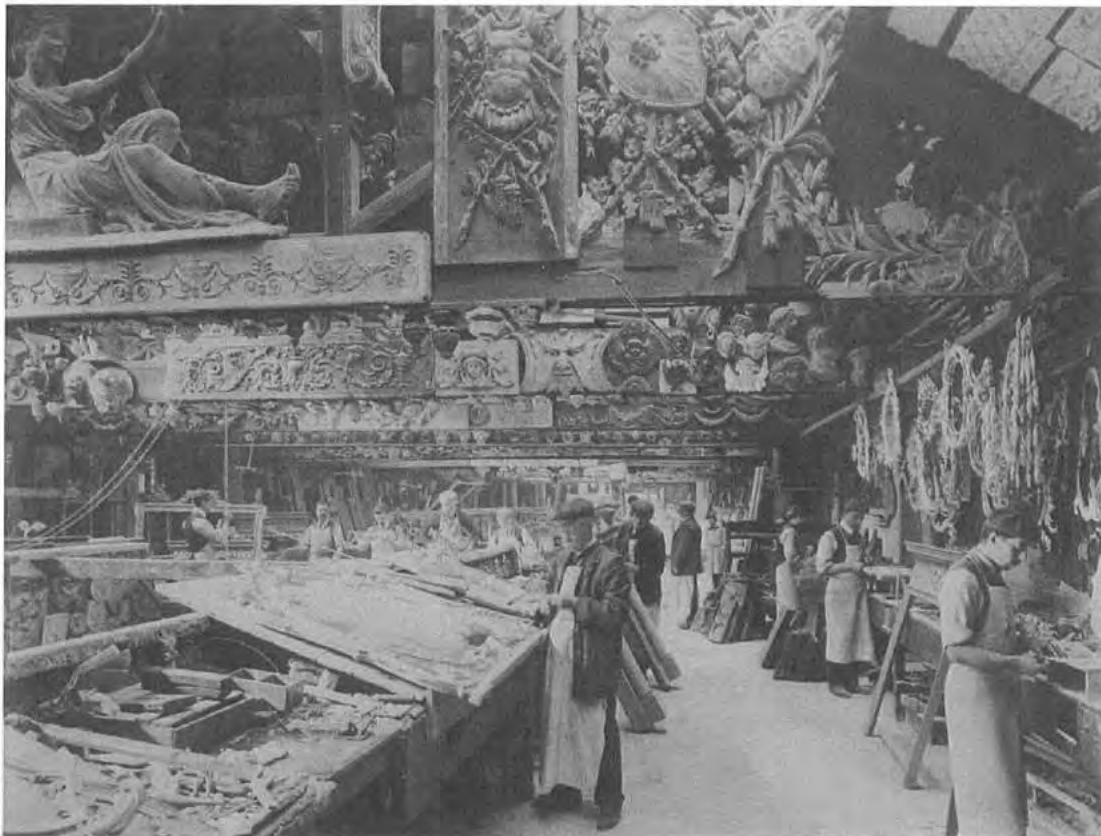
Plate 21 A plaster workshop in London late nineteenth or early twentieth century

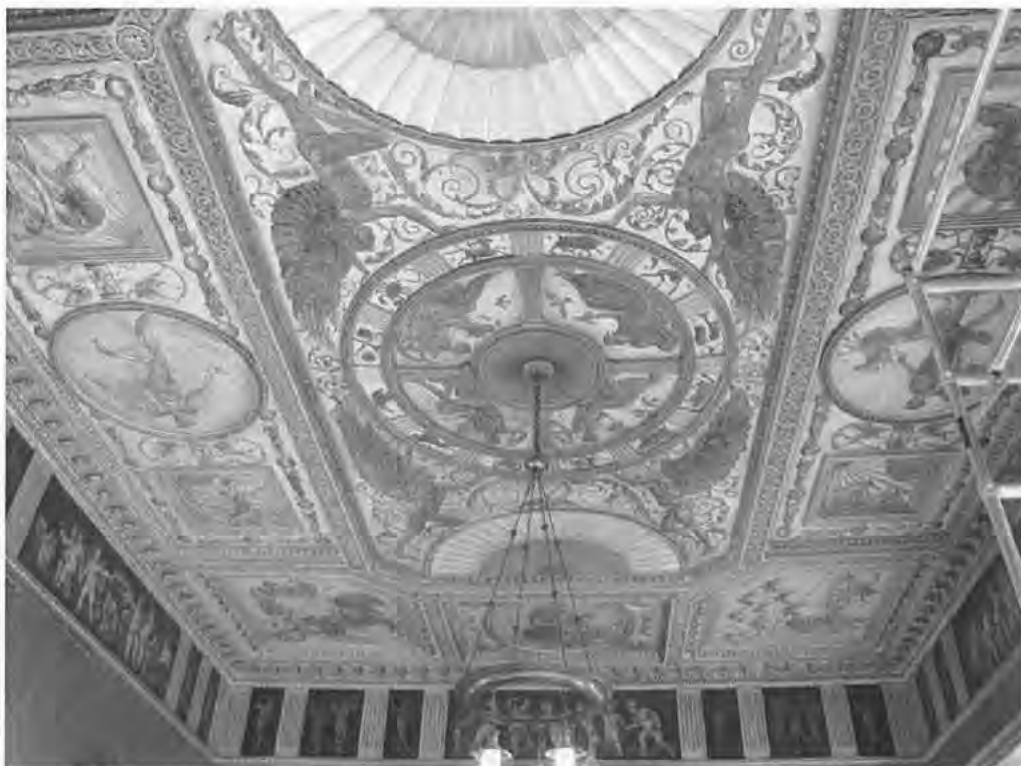
Plate 23 Walter Crane ceiling installation at Combe Bank Sevenoaks

Millar writing in 1897 notes that 'Fibrous plaster during the last two decades has been worked by other firms, and it is now open to all plasterers.'¹³ Large firms manufacturing fibrous plaster flourished across the country (see Plate 2) through the latter part of the nineteenth century. Fibrous plaster has been used for the Walter Crane panels in the Saloon at Combe Bank, Sevenoaks, Kent (1880). (See Plates 22 & 23)

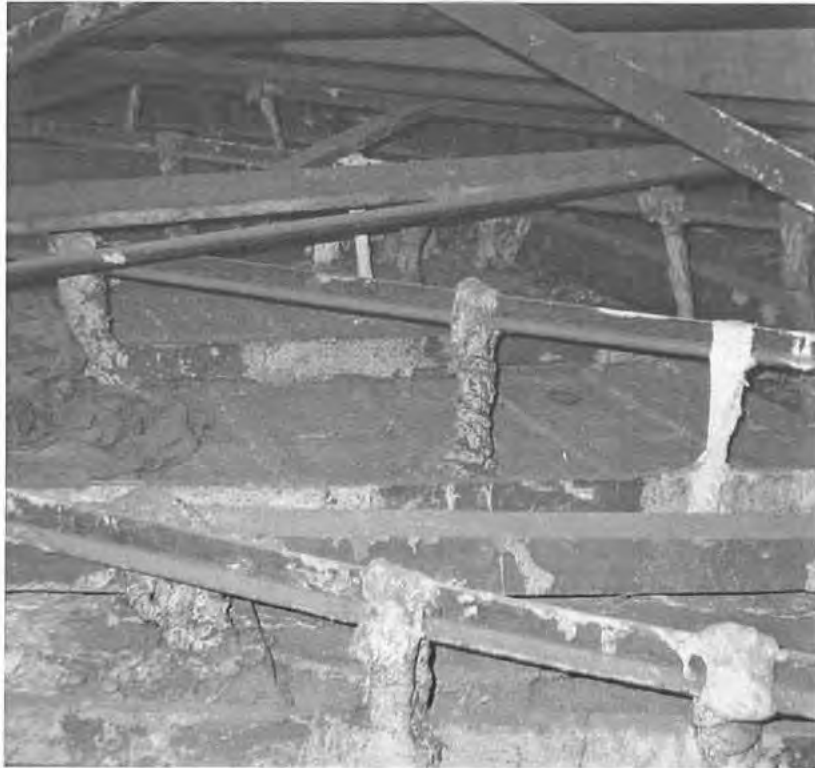
Plate 24 Typical wadding tie suspension system using hessian soaked in plaster of Paris.
Photo courtesy of English Heritage in *Mortars Renders & Plasters* (2012) p.109

The fourth 1927 edition of Millar notes 'The castings, when made, are fixed into position with brass screws or nails, or secured to metal work construction with "wads" or bandages of canvas steeped in liquid plaster, which are wrapped round the metal and held until set hard and firm.'¹⁸ The text continues 'This method of fixing is rigid and secure, and has never been known to fail.'¹⁹ (See Plates 14 & 24)

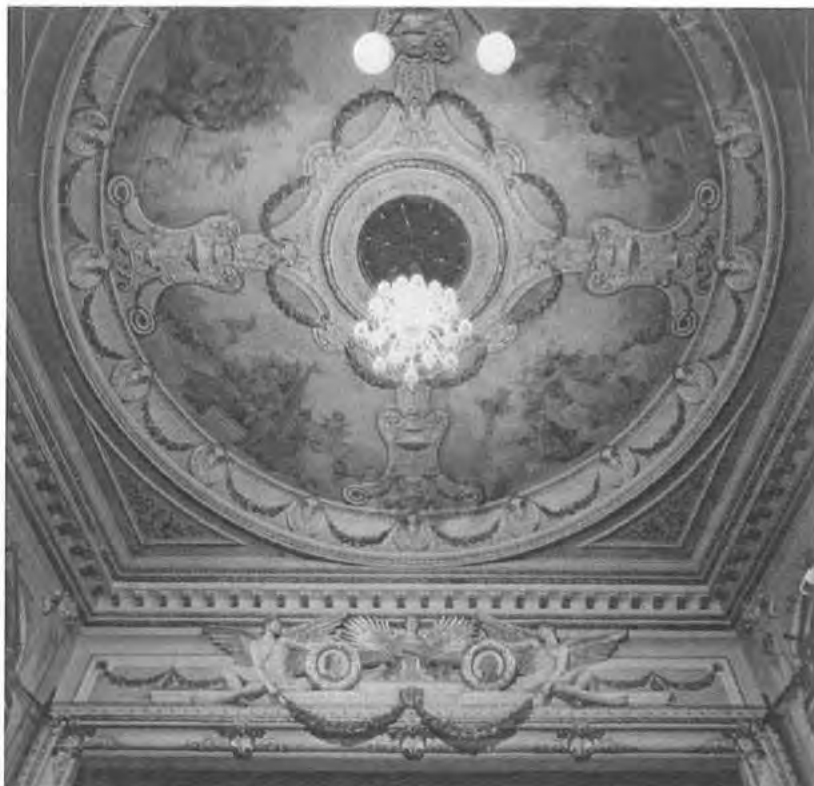
Plate 25 Wyndham's Theatre, London c.1898 one of the many period fibrous plaster ceilings
Photo courtesy of English Heritage in *Mortars Renders & Plasters* (2012) p.109

Millar goes on to note 'Nearly the whole of the numerous theatres and music-halls which have been built in London and the provinces during the last generation have been decorated with fibrous plaster'.¹⁴ (See Plate 25)
